METRO EAST END COMMUNITY ADVISORY BOARD HARRISBURG SIDEWALK COMMITTEE

WALKABILITY REPORT

MARCH 2013

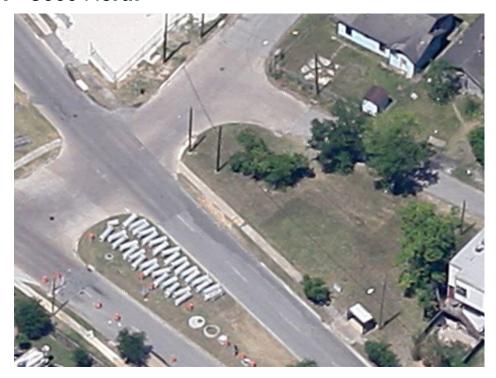
3.1 - 3000 North

Significant space along here for amenities, trees, bus shelter, & street furniture.

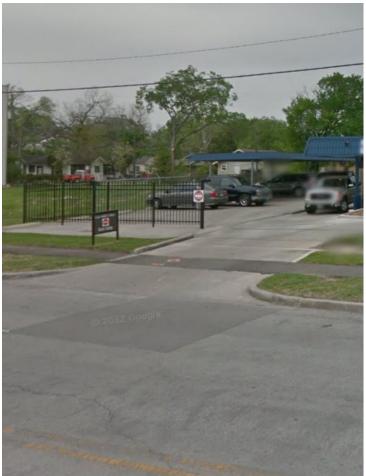
3.2 - 3000 North

Driveway needs striping.

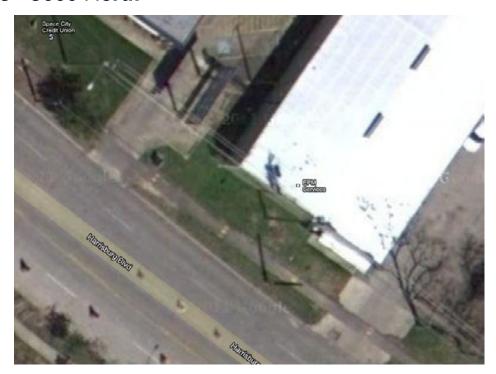
3.3 - 3000 North

Driveways need striping.

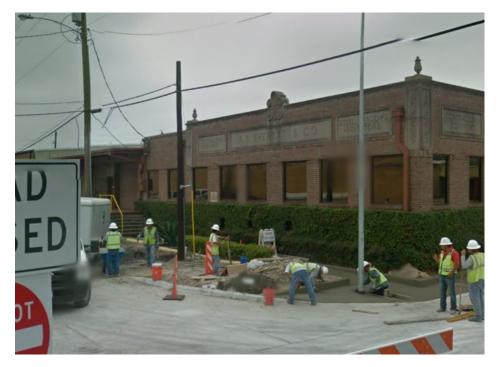
3.4 - 3000 South

Trees need planting.

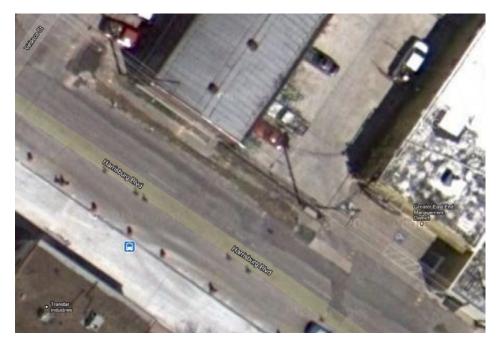
2B.1 - 3100 North

Enough room for bench at bus stop.

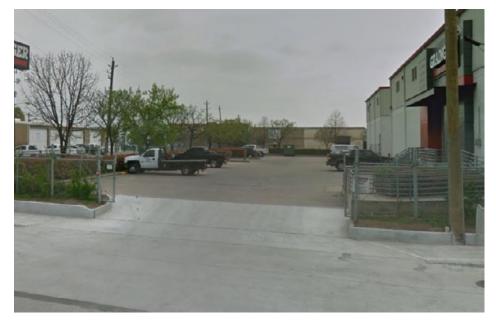
2B.2 - 3100 South

Driveway at GEEMD needs striping.

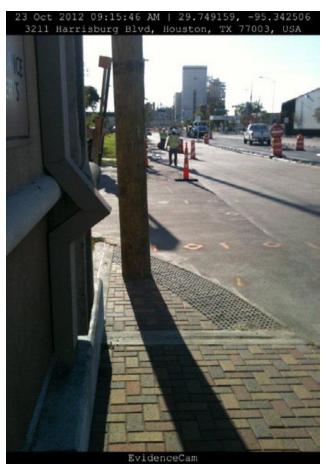
2B.3 - 3100 North

Power pole #226408 creates a walkability problem.

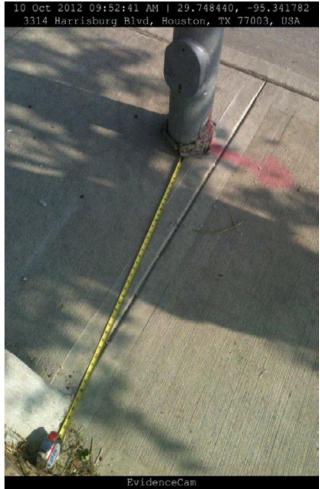
2B.4 - 3200 South

Power Pole #481378 creates a severe ADA compliance issue.

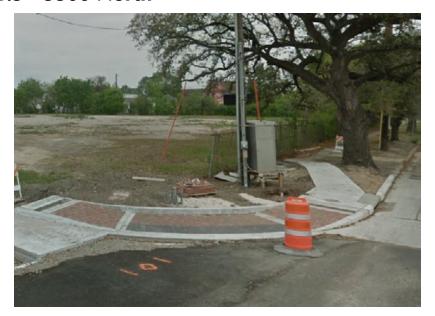
2B.5 - 3300 North

Potential for bench and trash receptacle on existing concrete pad.

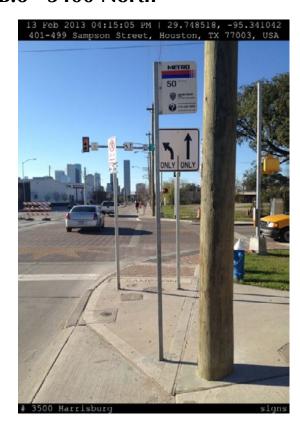
2B.6 - 3400 North

Many signs and a post in staggered proximity. Turn and No Parking signs placed close together.

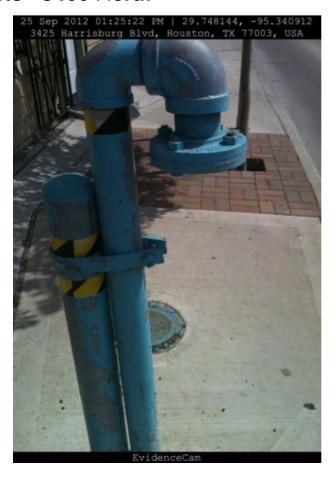
2B.8 - 3400 North

Encroachment into ROW by blue painted pressure relief valve.

Pipe head encroaches 9 " into this 33" space.

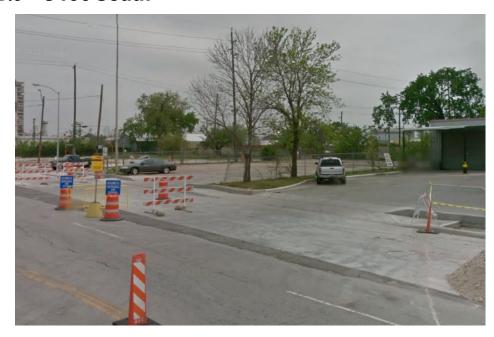
2B.9 - 3400 South

Three driveways need marking.

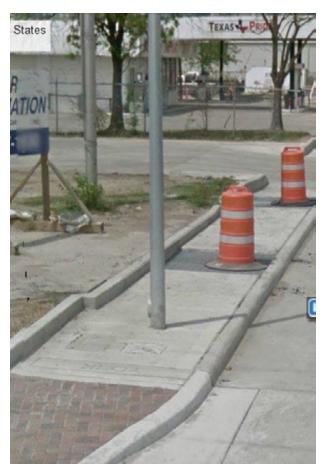
2B.11 - 3400 South

Power pole #481379 is placed in the middle of the sidewalk causing a really severe ADA and walkability issue.

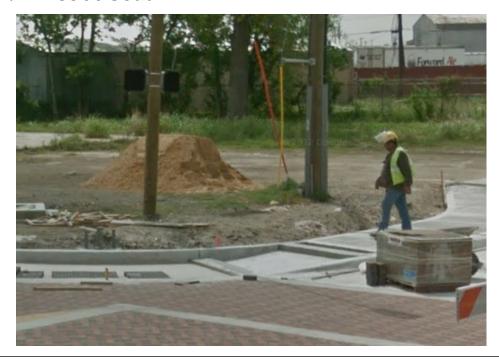
2B.12 - 3500 South

Add concrete pad for bike racks and street furniture.

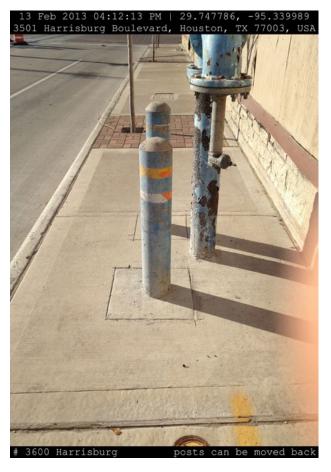
2B.13 - 3500 North

$30 \frac{1}{2}$ " from curb to release value and 24" from wall to release value.

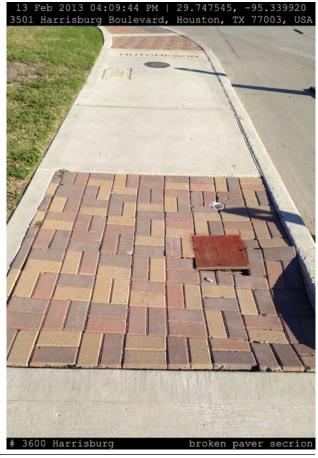
2B.14 - 3500 North

Paver section has been driven over with heavy equipment and is damaged.

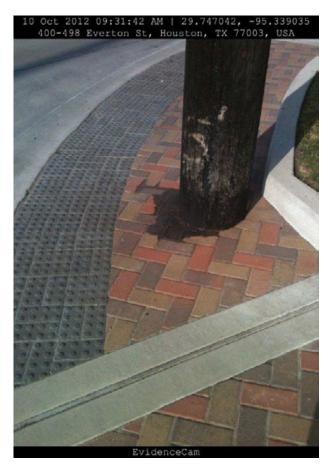
2B.15 - 3500 North

Power pole #226416 in sidewalk causing significant walkability issue at intersection.

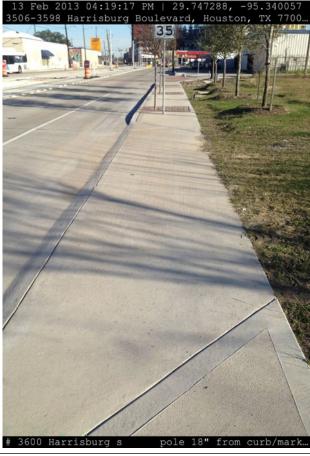
2B.16 - 3600 South

Traffic sign in middle of sidewalk decreases walkability. Driveway needs marking.

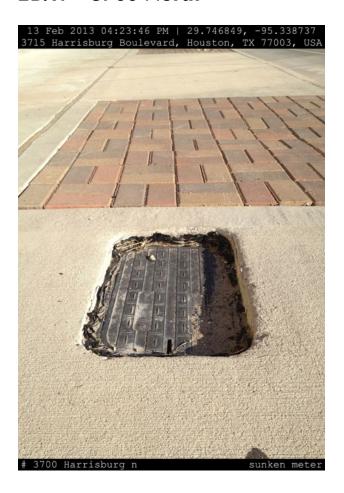
2B.17 - 3700 North

Sunken water meter in front of Rex Supply creates a tripping/walkability hazard.

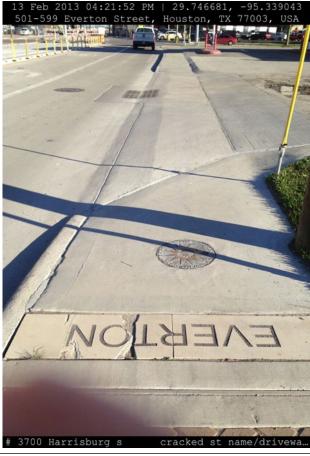
2B.18 - 3700 South

Street name block has been damaged.

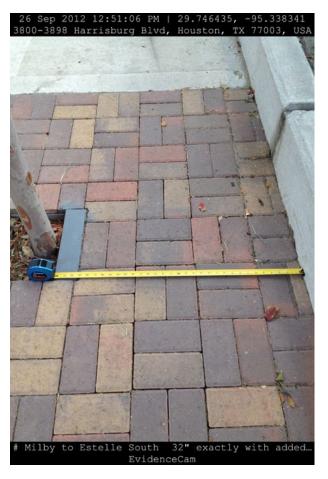
2A.1 - 3800 South

Exactly 32" from edge of added metal plate to concrete wall.

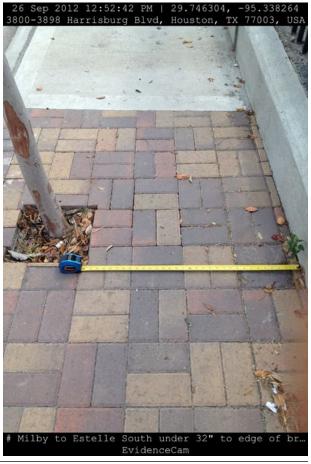
2A.2 - 3800 South

Distance from concrete wall to edge of brick is under 32".

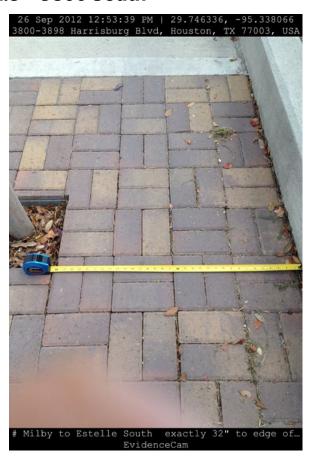
2A.3 - 3800 South

Exactly 32" from edge of brick to concrete wall.

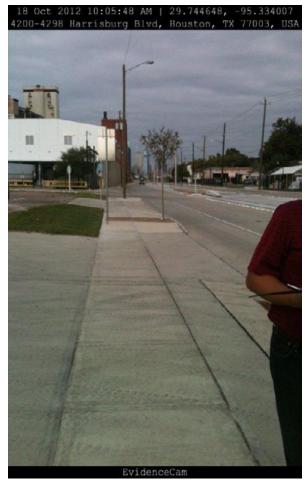
2A.4 - 4200 South

Power pole #664273 placed in the middle of the sidewalk creates a severe walkability issue.

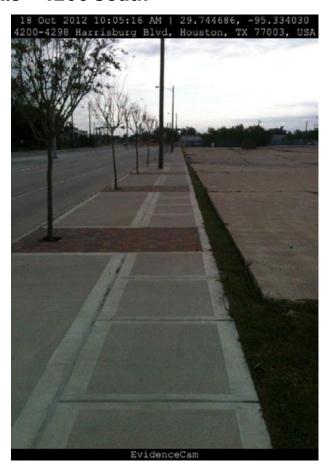
2A.5 - 4200 South

Power pole #664272 creates a severe walkability issue.

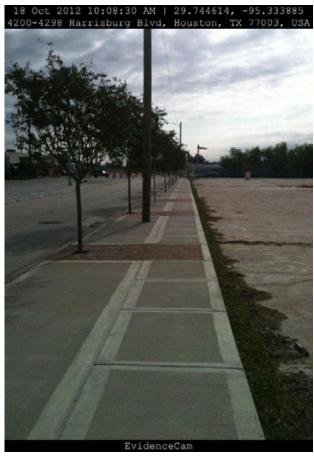
2A.6 - 4200 South

Power pole #664271 creates a severe walkability issue.

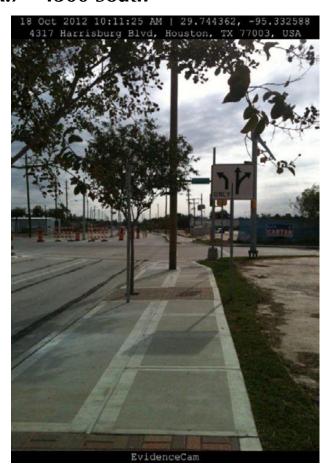
2A.7 - 4300 South

This unnumbered power pole creates a severe walkability issue.

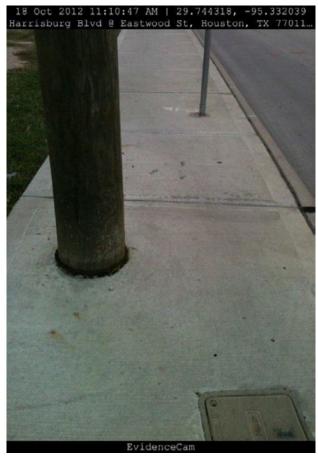
2A.8 - 4400 North

Power pole #664269 creates a severe walkability issue.

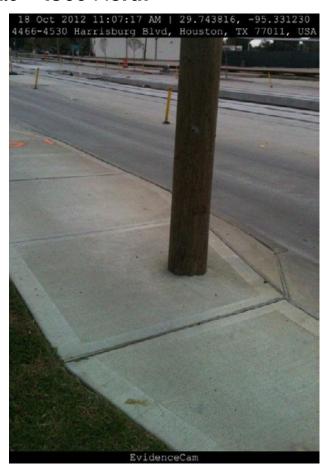
2A.9 - 4500 North

Power pole #664269 creates a severe walkability issue.

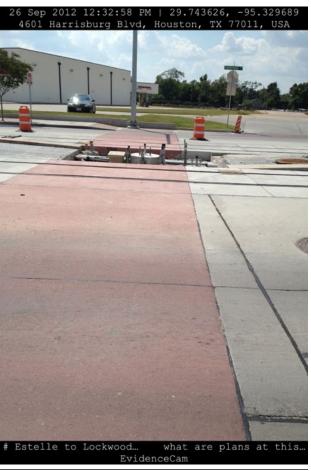
2A.10 - 4500 Platform

It appears that some apparatus will be positioned in the middle of this crosswalk, between the two platforms, potentially causing a walkability issue.

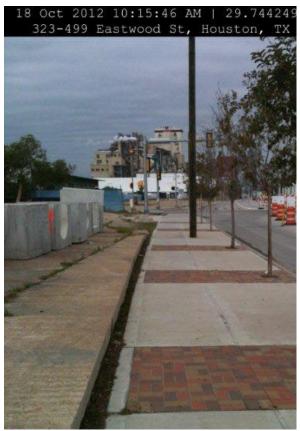
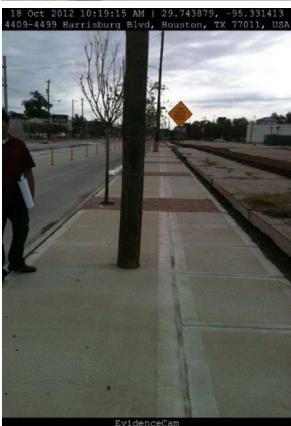
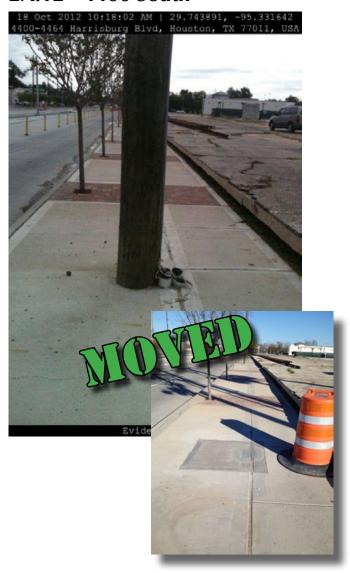
Power poles #664270 (2A.11), an unnumbered pole (2A.12), and #226438 (2A.13) create severe walkability issues.

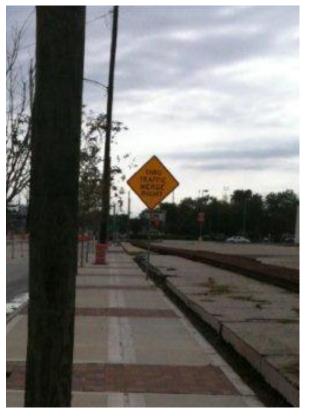
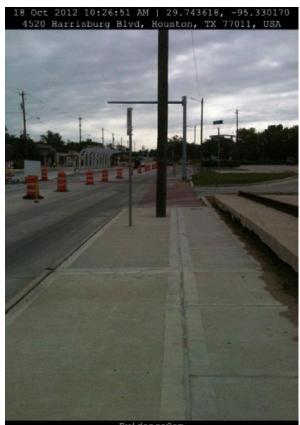
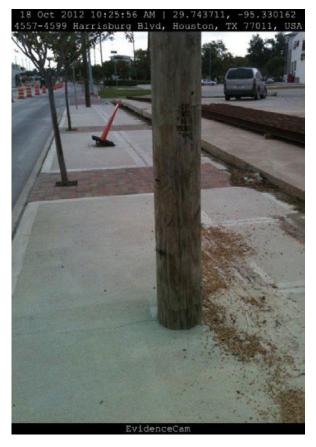
Power poles #226439 (2A.14), #664268 (2A.15), and #664267 (2A.16) create severe walkability issues.

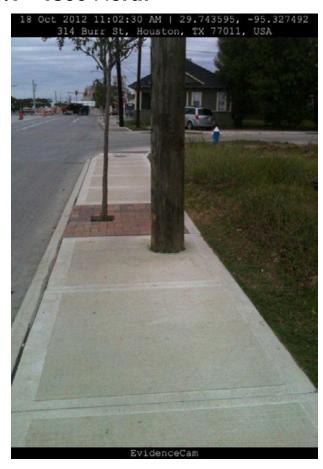
1B.1 - 4800 North

Power pole #226450 creates a severe walkability issue.

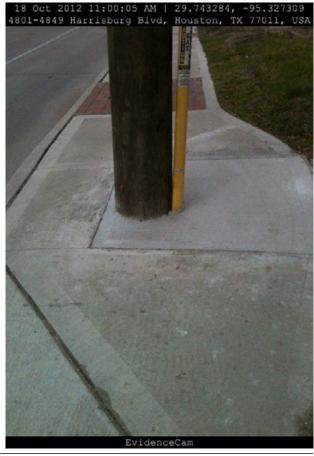
1B.2 - 4800 North

Power pole #664284 creates a severe walkability issue.

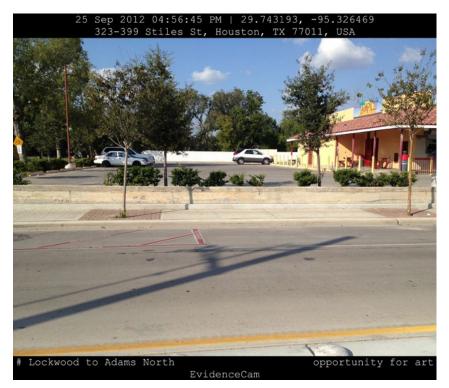
1B.3 - 4900 North

Unfinished wall. Possible location for art - faces Eastwood Park.

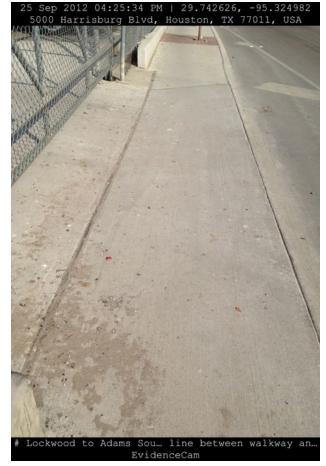
1B.4 - 5000 North

Driveway needs marking.

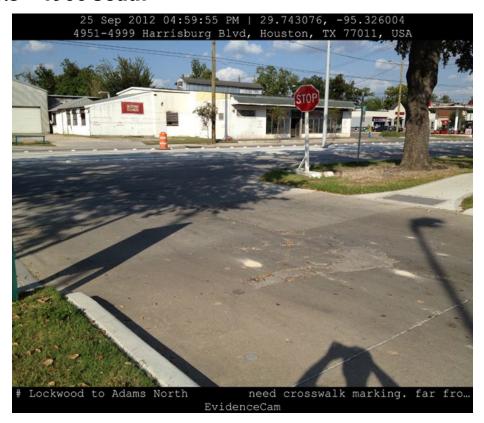
1B.5 - 4900 South

Sidewalk crossing needs to be marked.

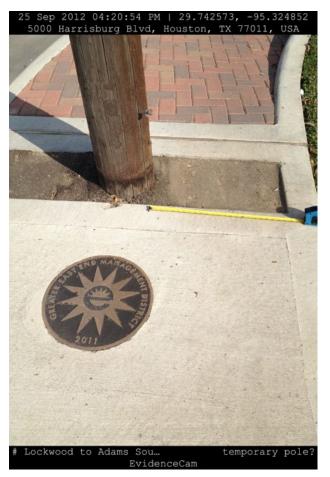
1B.7 - 5000 South

Power Pole 213090 creates a really sever walkability problem as well as being placed in the center of the walkway and in the space reserved and constructed by the Greater East End Management District for the street name.

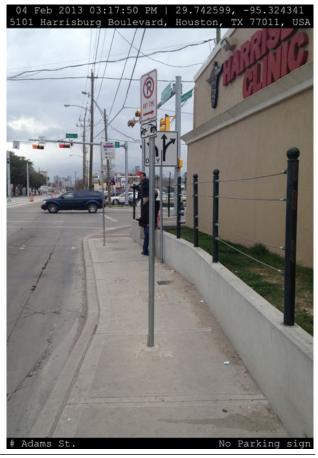
1B.8 - 5100 North

No Parking signs in center of walk creating a walkability issue.

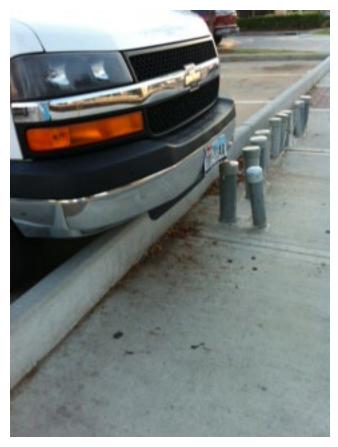
1B.9 - 5100 South

These posts appear to set to connect to something in the future. If so, additional barriers may be necessary to prevent contact with vehicles in the parking lot.

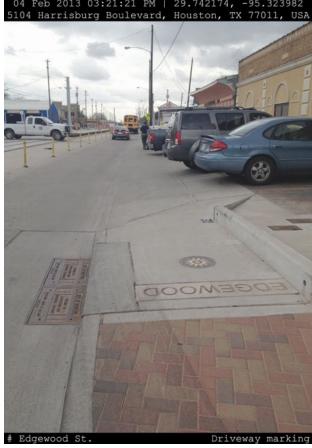
1B.10 - 5200 South Driveway needs marking.

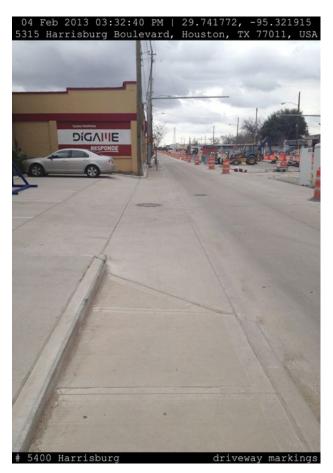
1B.11 - 5300 North

Driveway needs marking.

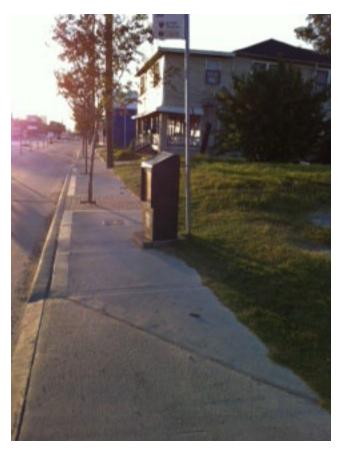
1B.12 - 5300 North

Newspaper dispenser on concrete pad attached with a chain and lock to a METRO bus stop pole impedes walkability.

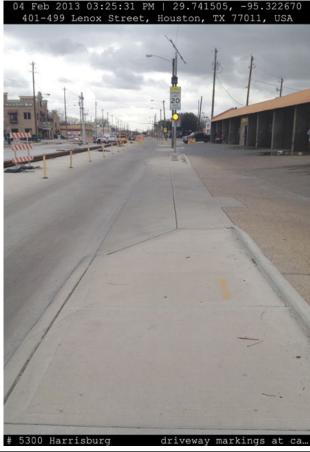
1B.13 - 5300 South Driveway needs marking.

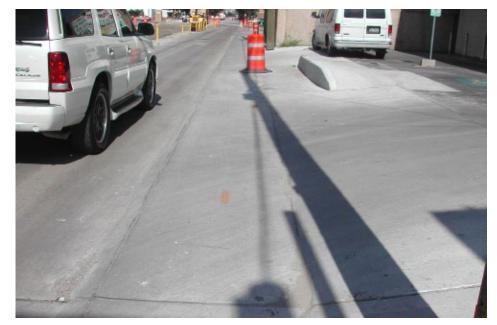
1.3 - 6600 North

Driveways need marking.

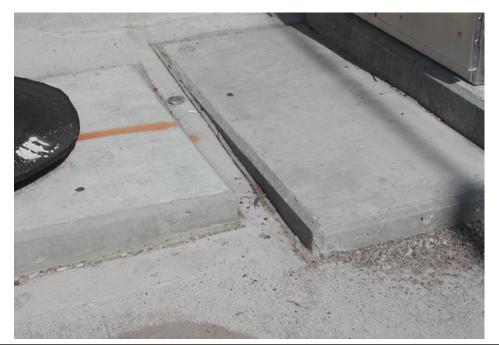
1.4 - 6600 North

Traffic control box and elevated underground utilities leaving a 4" wide by 5" deep gap; potential hazard.

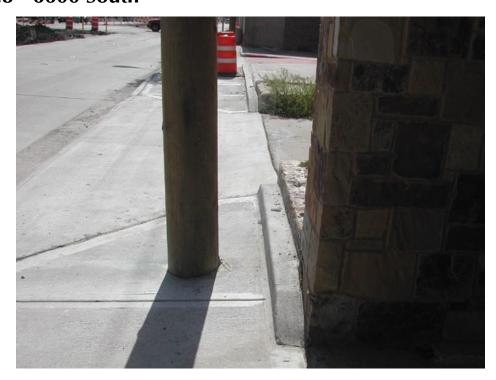
1.8 - 6600 South

6642 Harrisburg, street light poll is in middle of the sidewalk, causing a walkability issue. Drive needs marking.

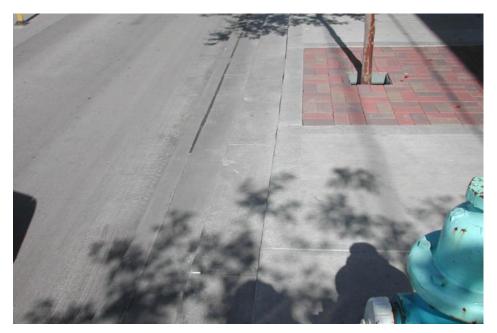
1.11 - 6700 North

Businesses along the 6700 block have a 96" wide sidewalk with two 6" high steps from the street to the sidewalk. This need a distinguishing way to see the steps and sidewalk edges—needs a handrail or painted marking.

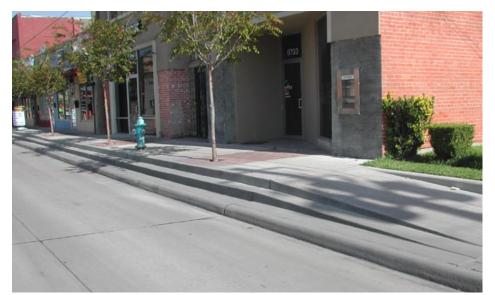
1.12 - 6700 North

AT&T parking lot has a 96-inch wide sidewalk with a green space of 32 1/2 inches to property line. Potential for landscaping or other amenities.

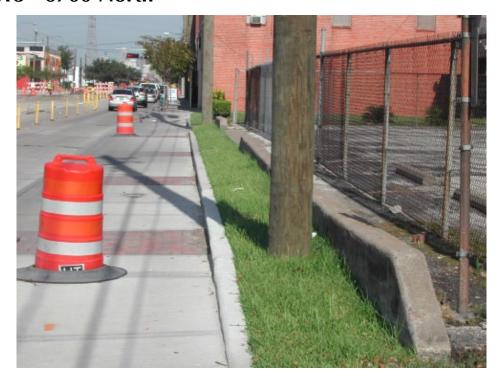
1.13 - 6700 North

In front of AT&T building, sidewalk is 129"; potential for benches or other amenities.

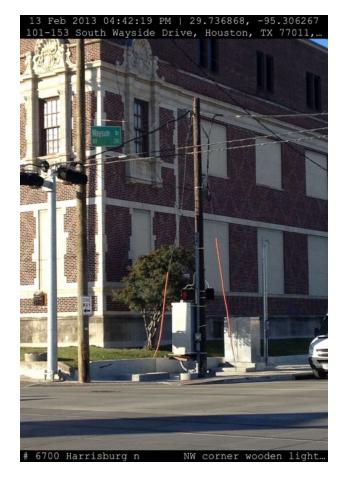
1.14 - 6700 North

Northwest corner has a wooden traffic light pole, two guide wires, and a signal box—remove and replace?

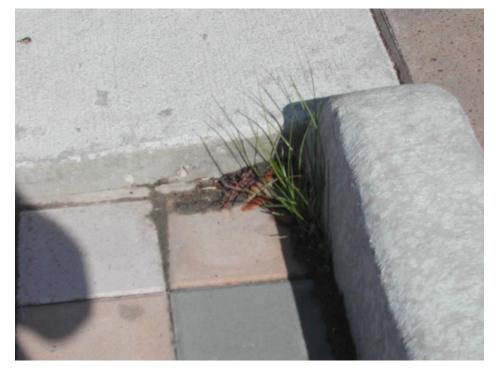
1.22 - 6800 North

6810 Harrisburg business—driveways are elevated 2 1/2" to 3" from sidewalk creating a tripping hazard.

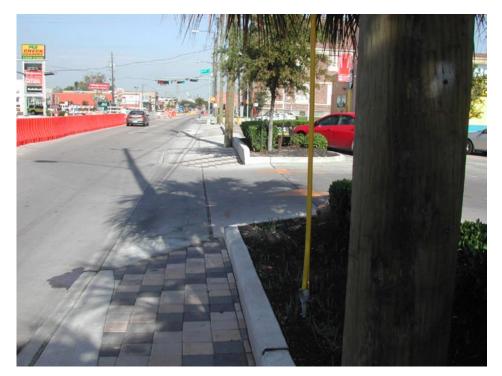
1.24 - 6800 North

McDonald's west driveway has wide sidewalks on both sides; 48" on the east and 95" on the west.

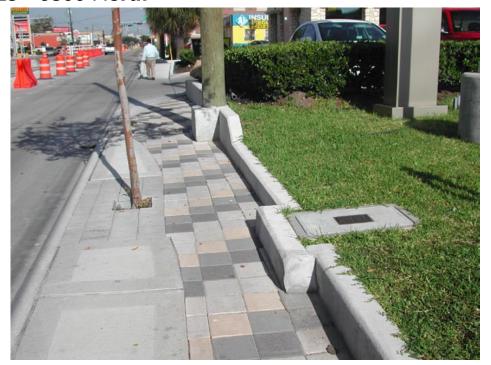
1.25 - 6800 North

In front of Wells Fargo Bank, both water meter box and utility pole sticks out 7" and 13", respectively, due to RT concrete box.

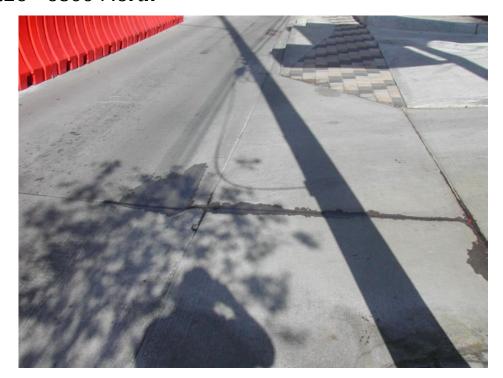
1.26 - 6800 North

All driveways along this block need markings.

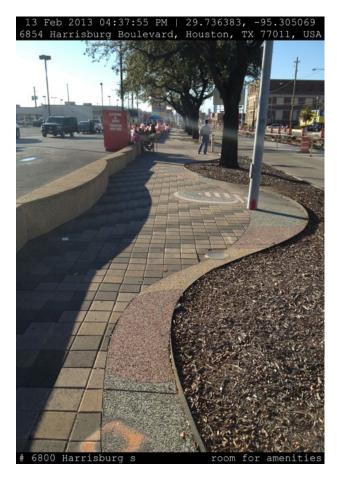
1.30 - 6800 South

Along this block there is ample room for bike racks and additional benches (currently there is only one bench).

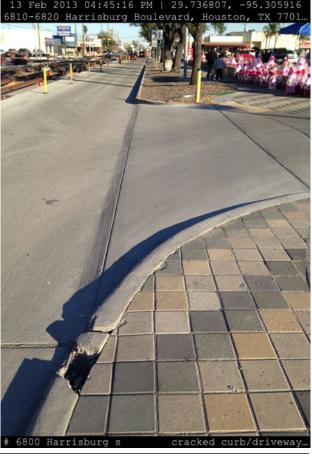
1.31 - 6800 South

All of the driveways on this block need markings. Curb at first driveway is broken.

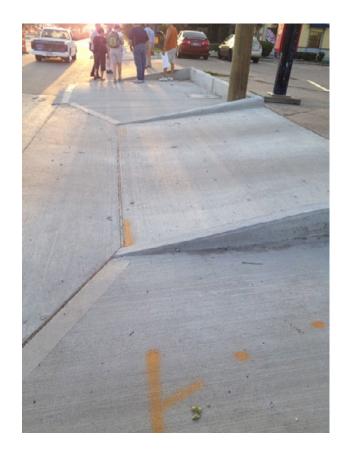
1.33 - 6900 North

Sidewalk is always directed toward street, due to slope—need to provide direction for pedestrians and provide warning to autos in street. Also, need to provide some "warning" (reflective paint?) on abrupt edges separating driveways into businesses from the sidewalks.

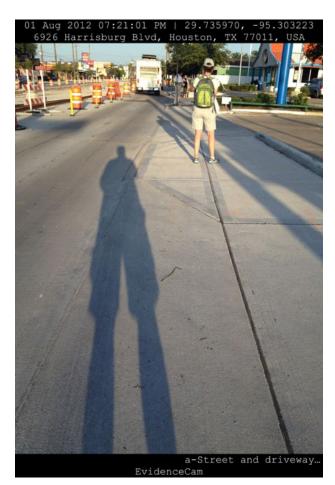
1.34 - 6900 South

In front of Payday store and Whataburger, provide driveway markings to avoid car/pedestrian interference.

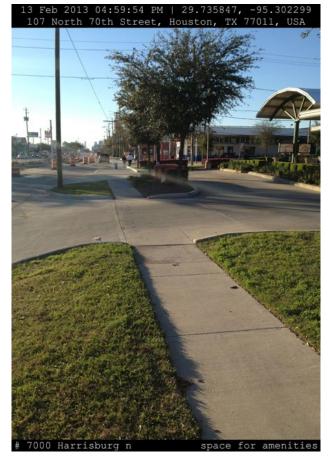
1.35 - 7000 North

In front of Sonic, and on side (70th St), space for bike racks and benches.

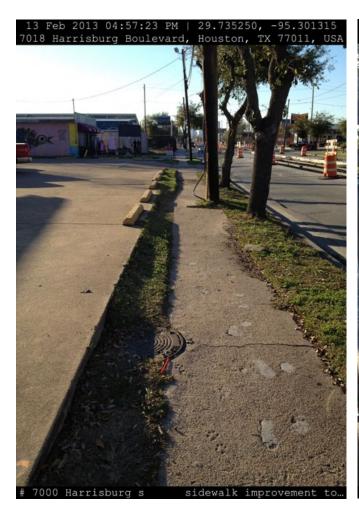
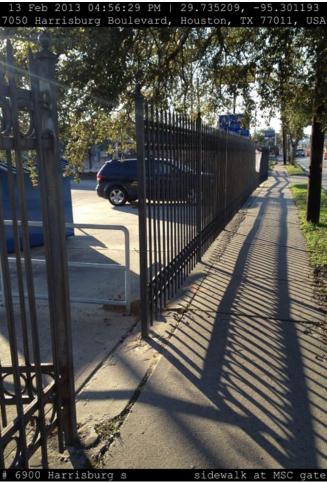
1.34 - 7000 South

The few feet from the end of the rail-related sidewalk replacement and the entrance to the Magnolia Multi-Service Center offers the potential for a sidewalk improvement for citizens taking the light rail to the Magnolia Transit Center.
