METRO EAST END COMMUNITY ADVISORY BOARD HARRISBURG SIDEWALK COMMITTEE

WALKABILITY REPORT

MARCH 2013

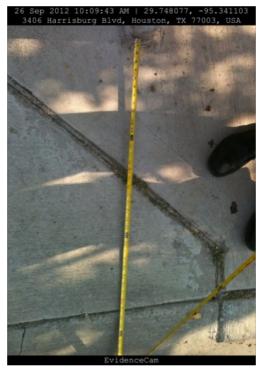
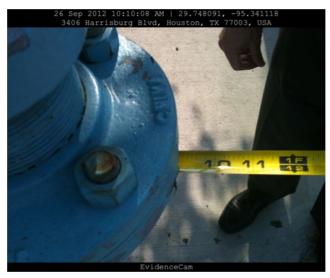
Encroachment into ROW by blue painted pressure relief valve.

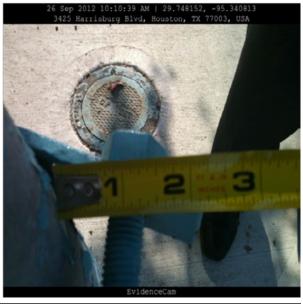
Pipe head encroaches 9 " into this 33" space.

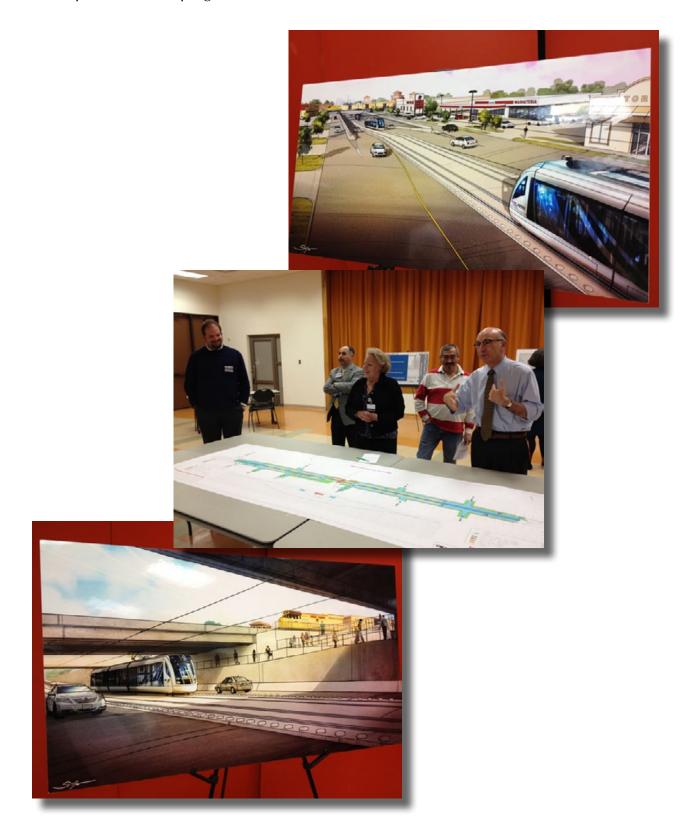
1A - 5500 - 6200

Underpass section in progress.
